PRELIMINARY SOIL AND GEOLOGICAL REPORT
FOR THE
BLACK FOREST GLIDER PARK SUBDIVISION
ELBERT COUNTY, COLORADO

PREPARED FOR:
MR. BEN KELLY
2570 E. SAN MIGUEL
COLORADO SPRINGS, COLORADO 80909

January 19, 1986

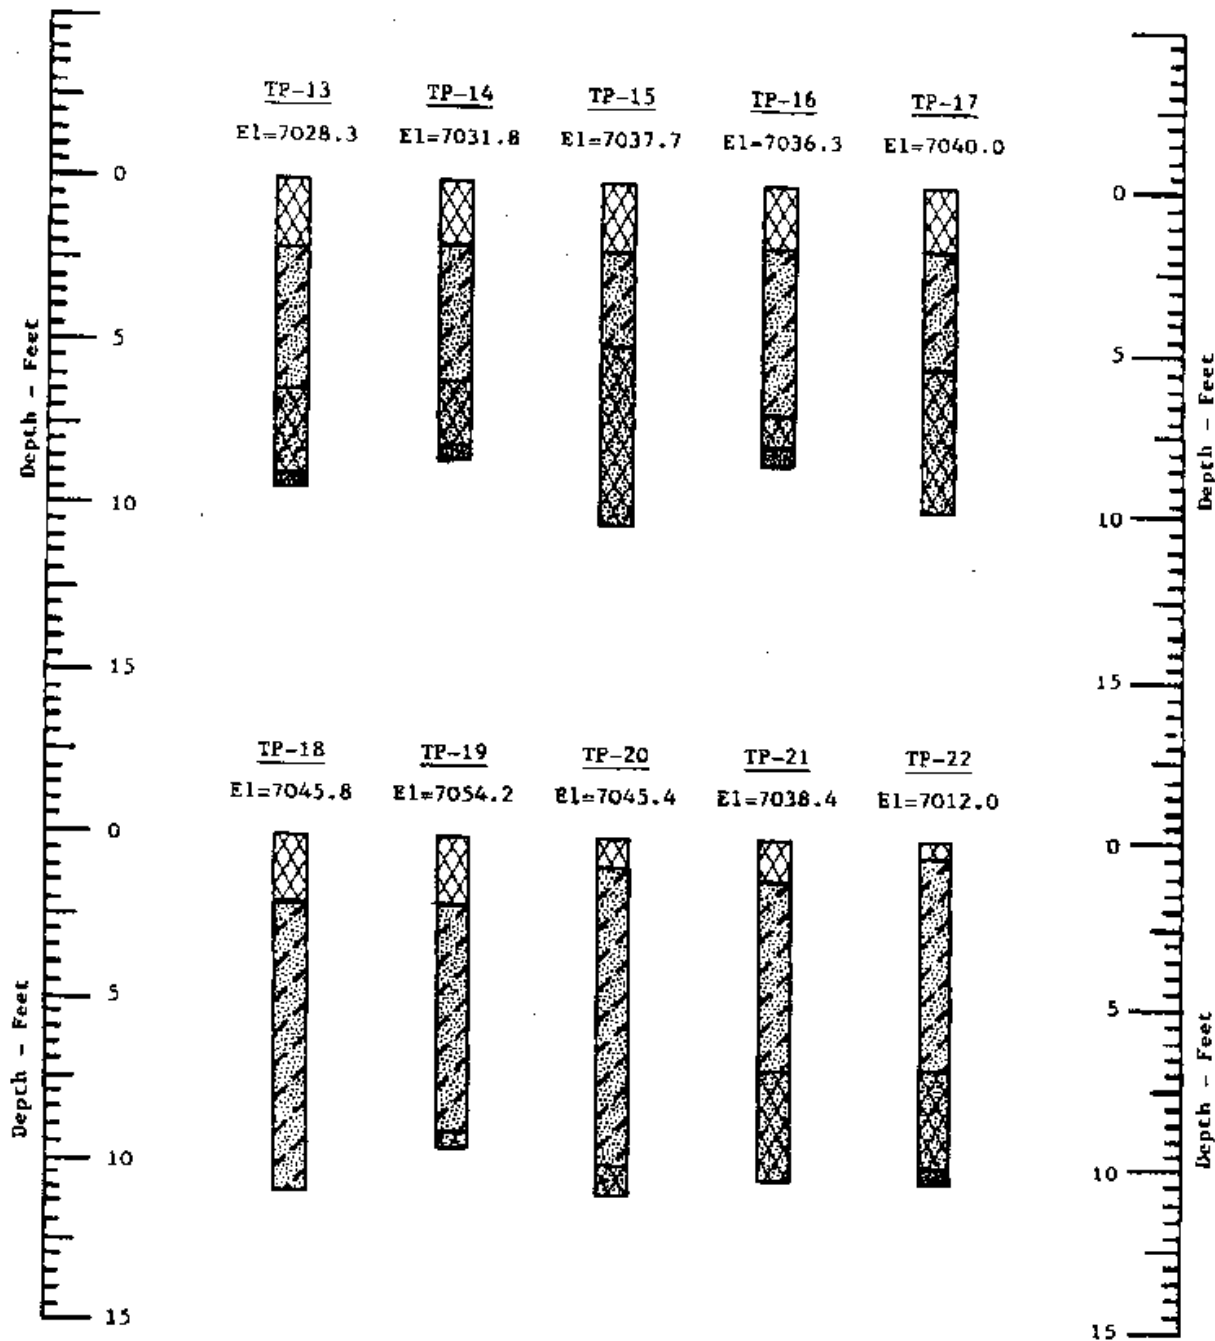
Figure 3

BORINGS

The subsurface soil conditions for this site were explored using a backhoe and digging 22 test pits as shown on the attached topographic map. The logs for these exploratory holes are shown on pages 8 and 9. The exploratory holes were dug in December of 1986 with a 2 to 4 inch snow cover, which probably explained why only 1 to 2 inches of frost were encountered.

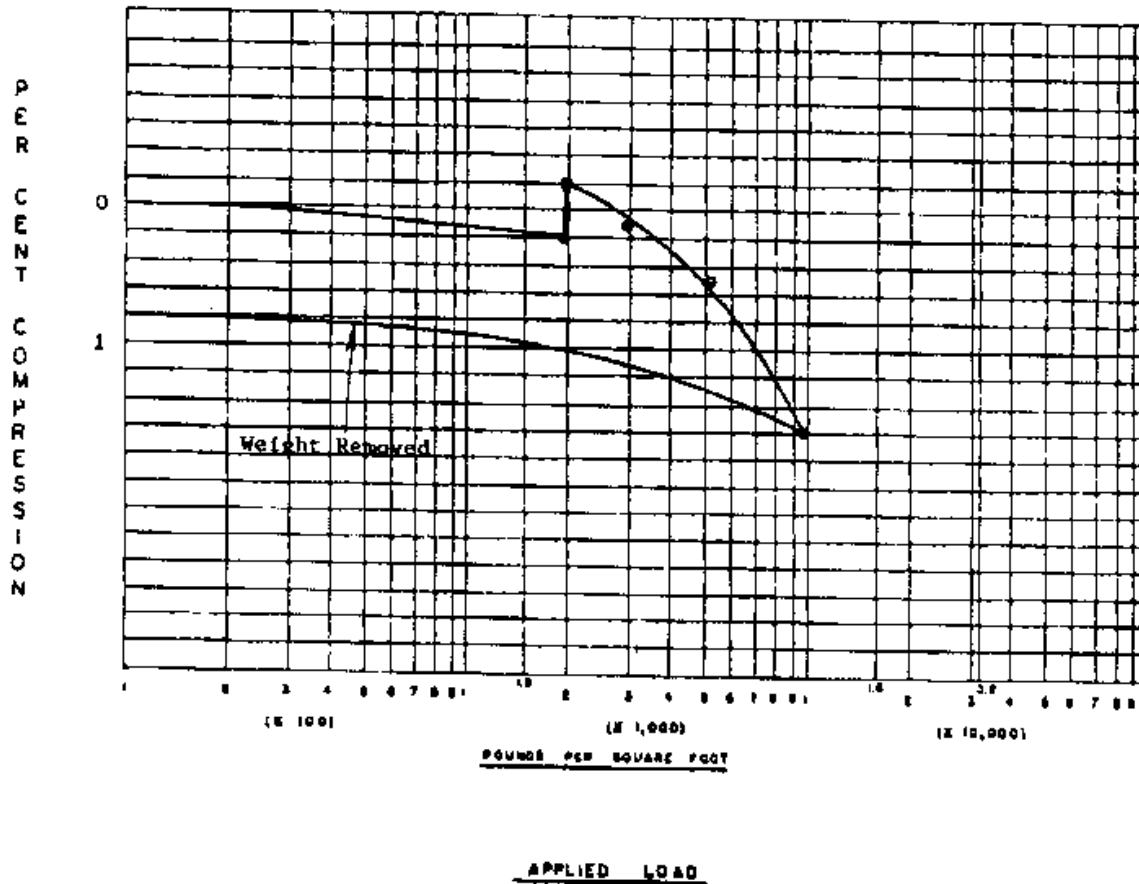
Figure 6

CONSOLIDATION TEST

Test hole No. <u>2</u>	Sample Depth <u>66"</u>
Soil Classification <u>Sandy Clay</u>	
In situ Density (lb./ft. ³) <u>113.1</u>	Initial Moisture % <u>26.8</u>
Dry Density (lb./ft. ³) <u>89.2</u>	
% Swell <u>0.2</u>	% Consolidation <u>1.6</u>

not require any special foundation applications. Due to the fact that some swell potential was noted (see swell consolidation test results pages 11 through 13) it is highly recommended that each structure obtain a soil report and foundation design to minimize any potential foundation problems.

In conclusion the results of the soil tests presented in this report indicate that there are no soil conditions which should adversely effect proposed construction on this property. The results of the swell consolidation test presented on pages 11 ,12 and 13 indicate moderate swell potential for the sandy clay material, however this should not present a design problem. The soil profiles presented on pages 8 and 9 indicate approximate soil horizons and some variation may occur, therefore it recommended that an open hole inspection be performed at each building site to verify soil conditions. If any marked variation from the soil profile and/or conditions are noted during construction additional soil tests should be performed.

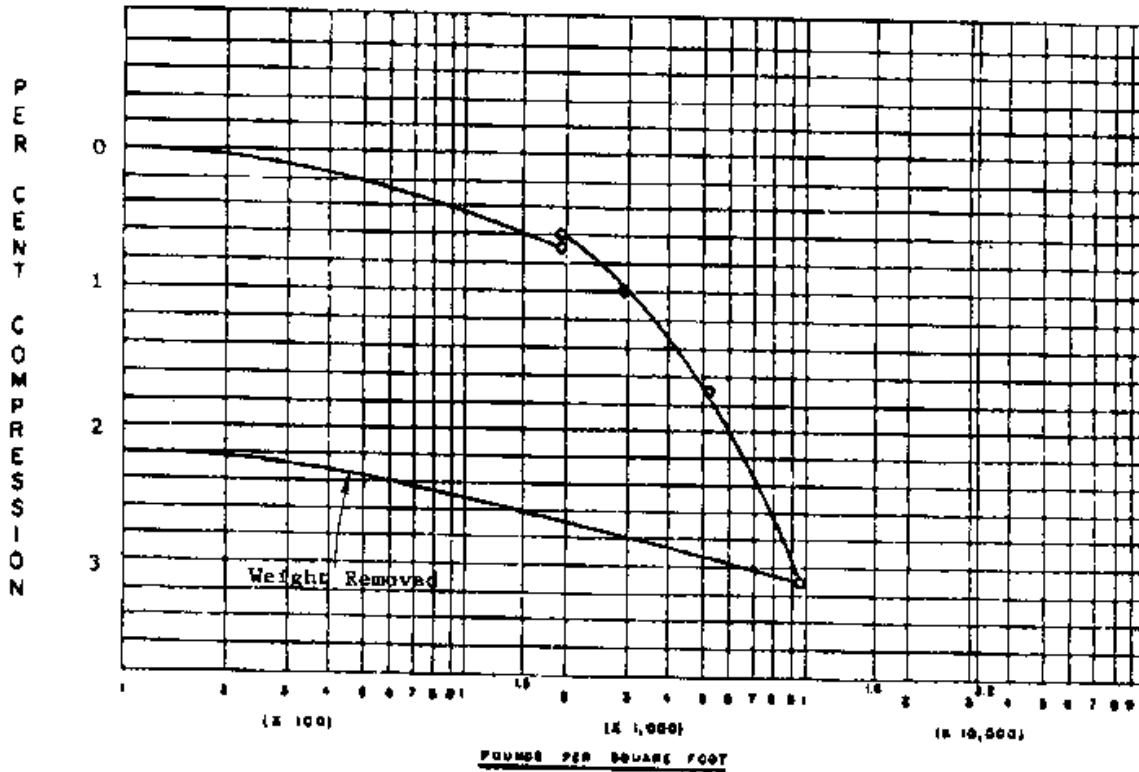
CONSOLIDATION TEST

Test hole No. 2 Sample Depth 108"
 Soil Classification Slightly Gravelly Sandy Clay
 In situ Density (lb./ft.³) 107.2 Initial Moisture % 33.7
 Dry Density (lb./ft.³) 80.2
 % Swell 0.0 % Consolidation 3.1
